SUSQUEHANNA RIVER BASIN
BLAIR GAP RUN, BLAIR COUNTY

BLAIR GAP DAM

NDI I.D. NO: 521

PHASE I INSPECTION REPORT
NATIONAL DAM INSPECTION PROGRAM

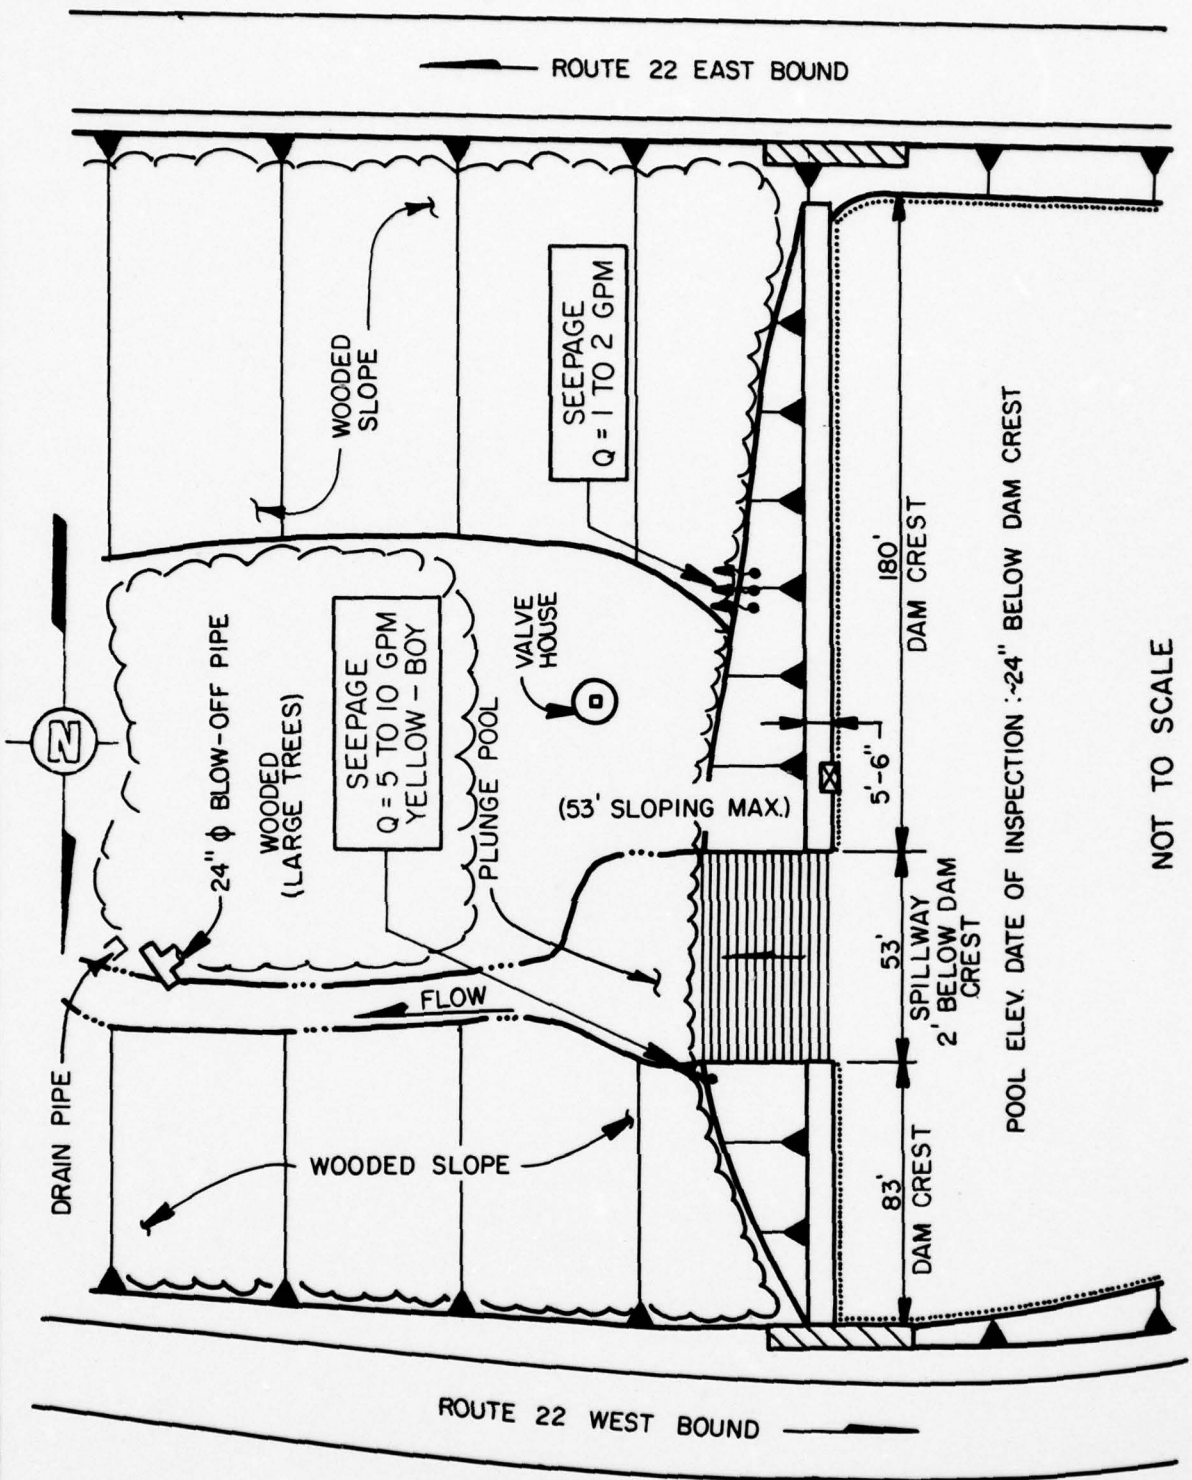
VISUAL EXAMINATION OF	OBSERVATIONS	REMARKS OR RECOMMENDATIONS
ANY NOTICEABLE SEEPAGE	AT TWO LOCATIONS THROUGH THE DAM SEE PLATE 3 FOR LOCATION.	
STRUCTURE TO ABUTMENT/EMBANKMENT JUNCTIONS	NO SIGNS OF DISTRESS OR SEEPAGE.	
DRAINS	NONE FOUND.	
WATER PASSAGES		
FOUNDATION	NO SIGNS OF DISTRESS.

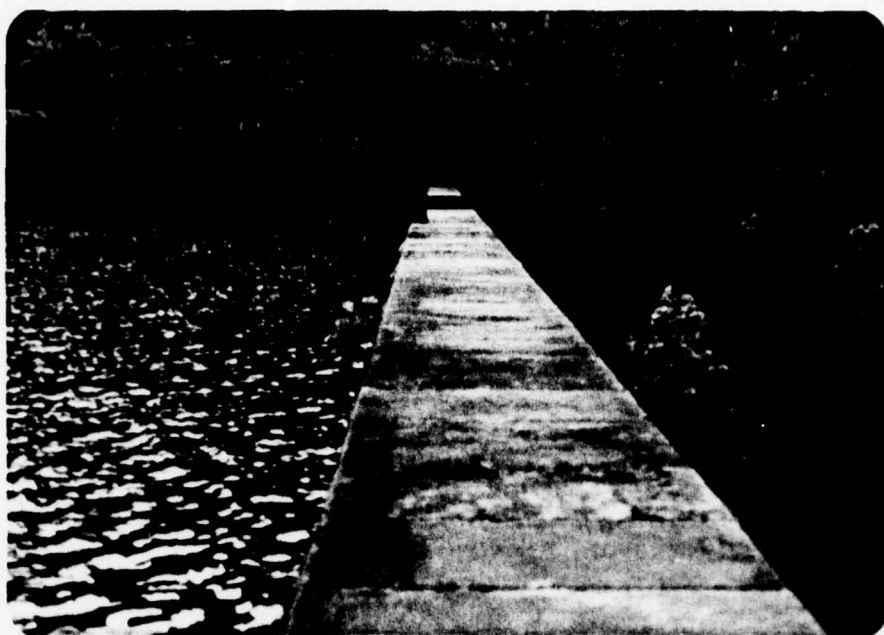
Photograph No. 1
Crest (looking south).

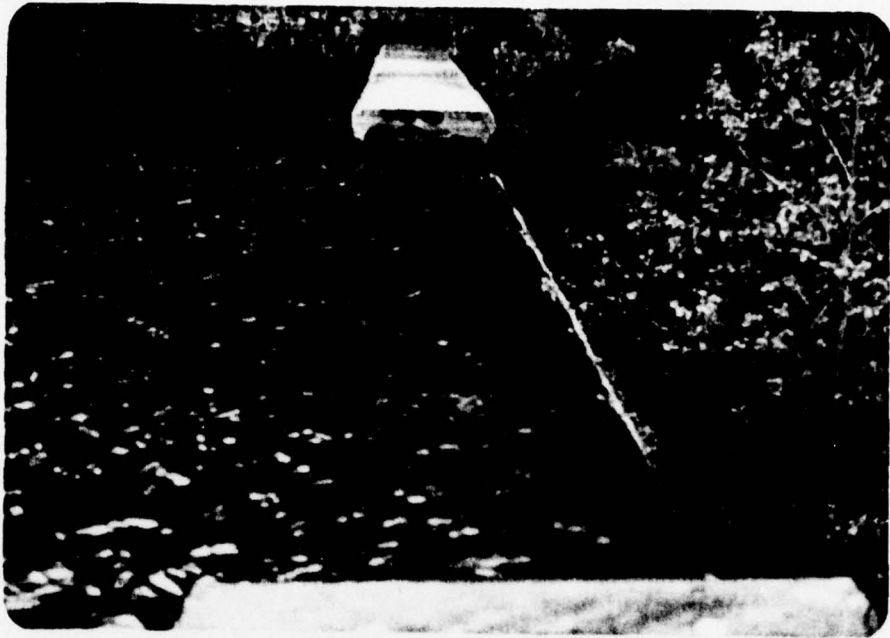
c. Appurtenant Structures. The spillway crests and plunge pools were examined for deterioration or other signs of distress and obstructions that would limit flow. No signs of apparent distress or erosion were observed. Water company personnel declined to operate the blow-off valve so its condition is not known.

Photograph No. 3
Spillway crest.

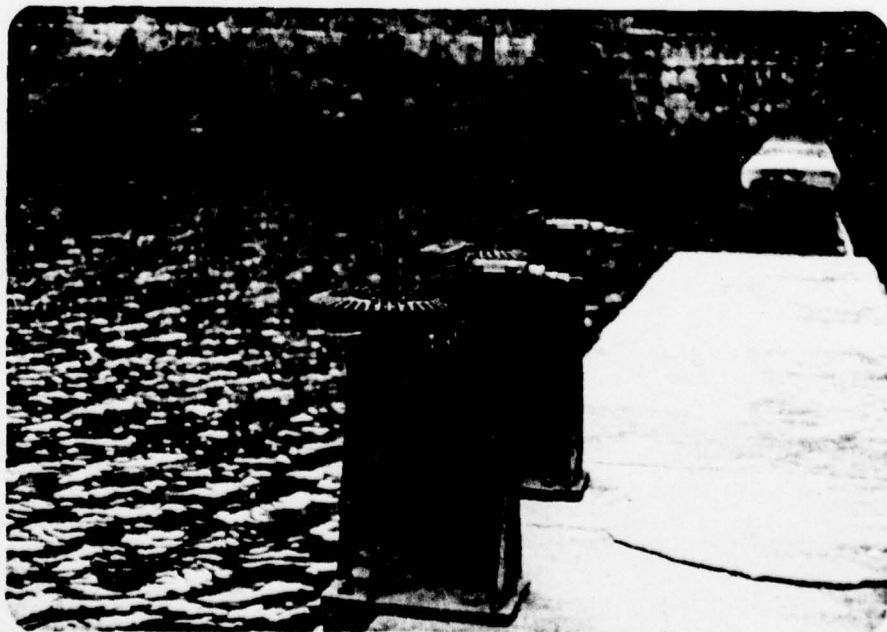
Photograph No. 4
Valve controls on crest.

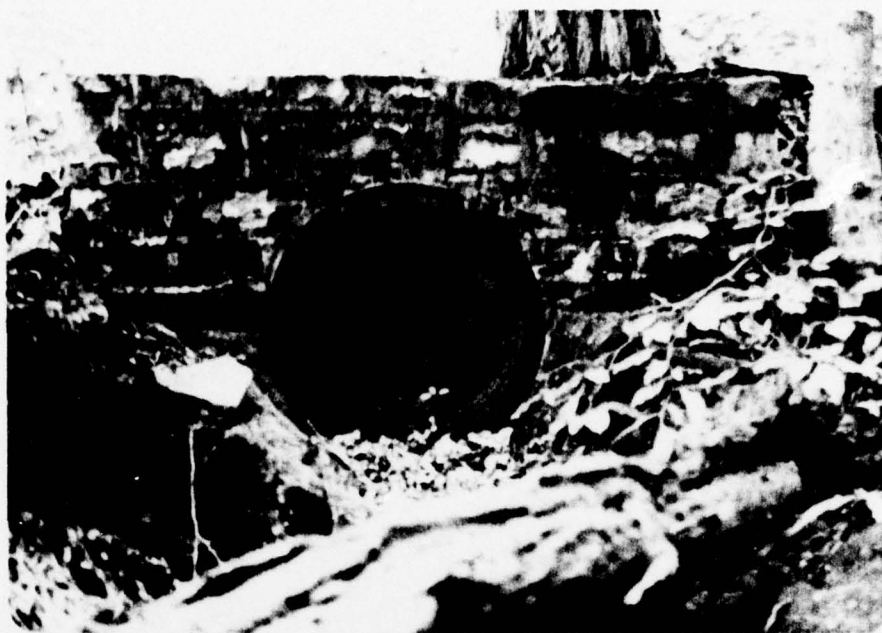
4.3 Maintenance of Operating Facilities. The water company declined to operate the blow-off valve for the dam without compensation for this service plus any damages due to operation of the valves. Therefore, the operative condition of the drawdown facilities could not be assessed. In general, the equipment appears to be in poor condition.

Photograph No. 5
"Blow-off" pipe.

1. It is recommended that the owner immediately evaluate the operational condition of the lake blow-off valve and perform necessary maintenance.
2. Because the dam may overtop during unusually high runoff, it is recommended that during such periods the owner should provide around-the-clock surveillance for early detection of problems, such as erosion of the abutments.
3. It is recommended that brush and trees in the toe area should be cleared over a distance of approximately 20 feet from the toe to permit adequate future inspection of the toe area.

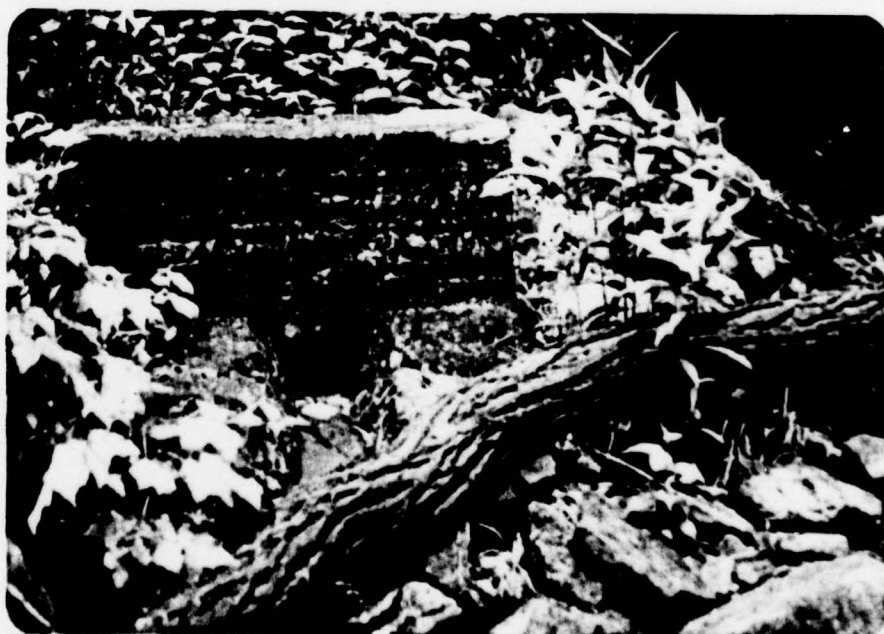
Photograph No. 6
Drainpipe adjacent to "blow-off" pipe outlet.

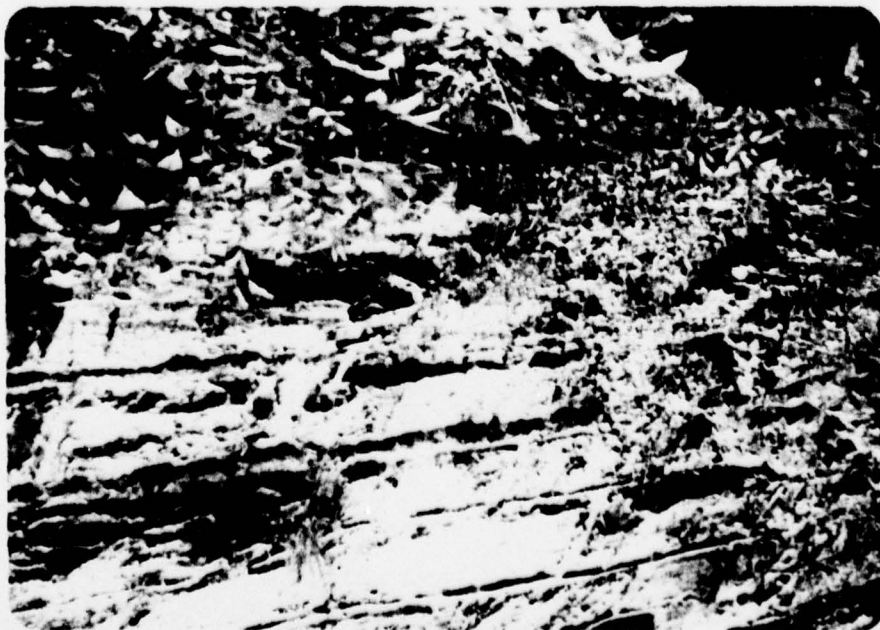
Photograph No. 8

1. Portions of the downstream face of the dam were found to be wet. Several seeps were located on the right side of the spillway. The discharge from these seeps was estimated to be one to two gallons per minute.
2. A concentrated seepage was found at the toe of the dam on the left side of the spillway. The discharge was estimated to be in the range of 5 to 10 gallons per minute. The seepage surface was covered with "yellow-boy" precipitate.

Seepage on left abutment toe (note yellow boy).

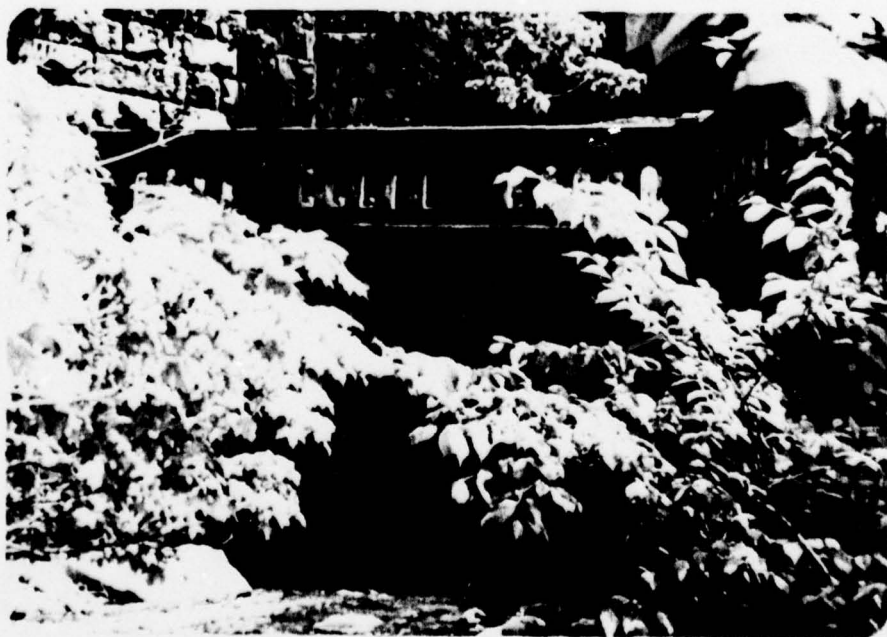
Photograph No. 10
Bridge on Route 22 westbound. (Note abutment
of railroad bridge on upper left corner.)
